STABILITY ANALYSIS OF STRUCTURES

BIRCH HILL DAM

2 MILLERS RIVER, MASSACHUSETTS

APRIL 1977

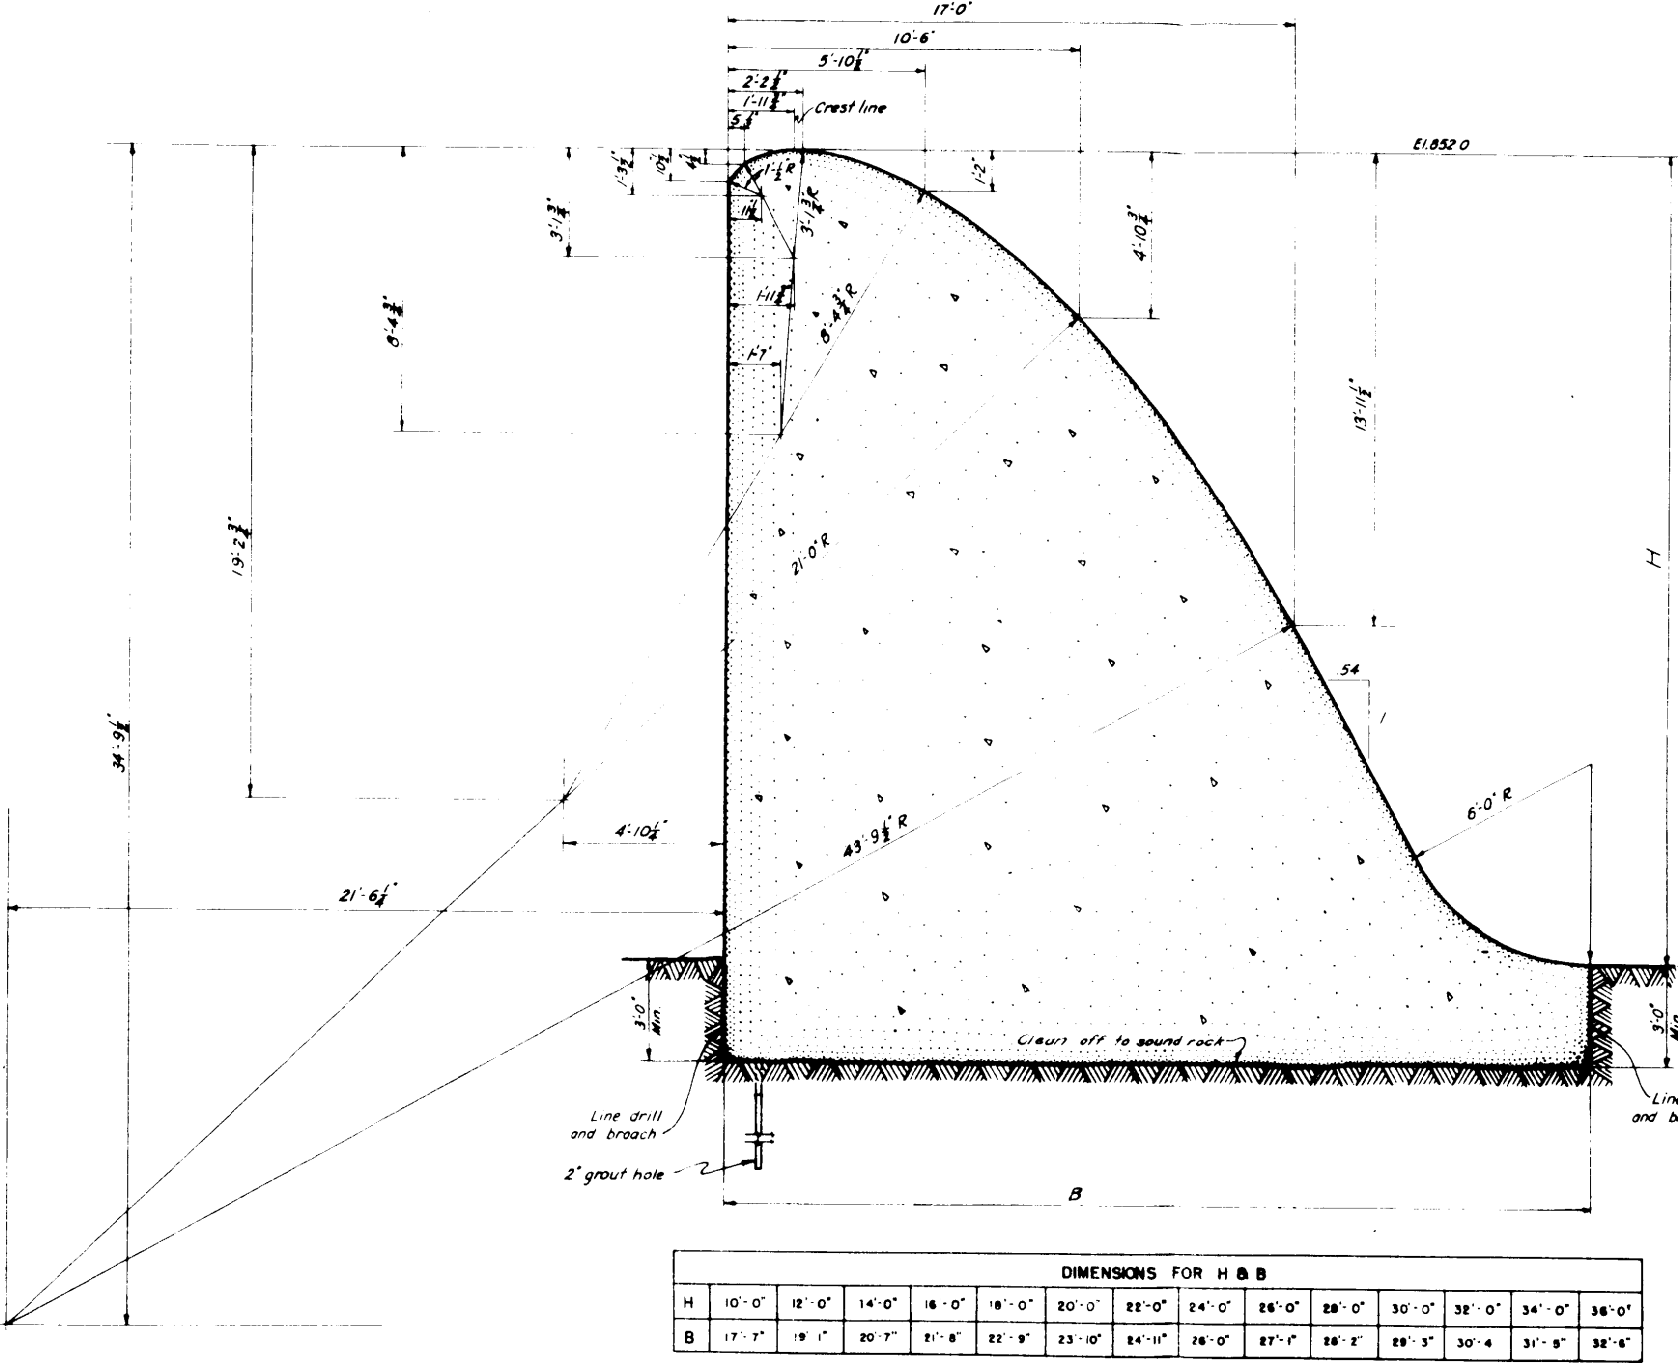
SPILLWAY SECTIONS FOR H=10FT. TO H=36 FT.

DIMENSIONS FOR H & B													
H	10'-0"	12'-0"	14'-0"	16'-0"	18'-0"	20'-0"	22'-0"	24'-0"	26'-0"	28'-0"	30'-0"	32'-0"	34'-0"
B	17'-7"	19'-1"	20'-7"	21'-8"	22'-9"	23'-10"	24'-11"	26'-0"	27'-1"	28'-2"	29'-3"	30'-4"	31'-5"

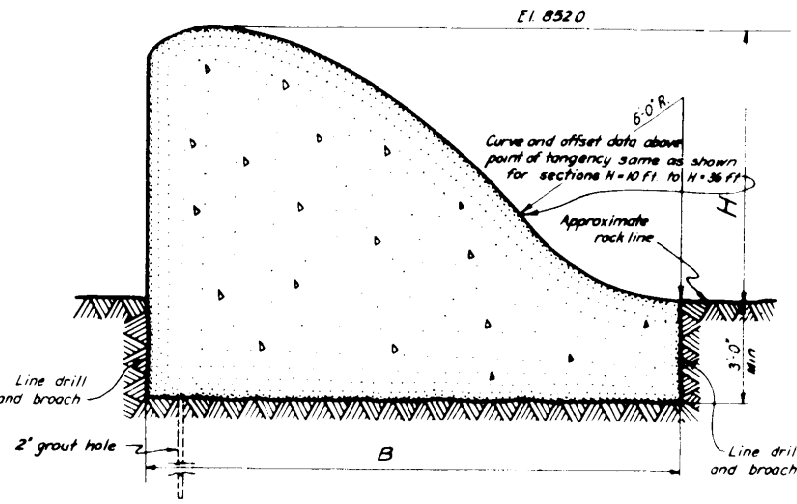
SPILLWAY SECTIONS FOR H=2 FT. TO H=8 FT.

DIMENSIONS FOR H & B				
H	2'-0"	4'-0"	6'-0"	8'-0"
B	8'-11"	11'-10"	14'-1"	15'-11"

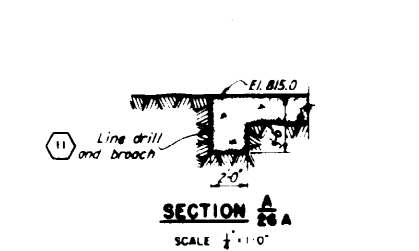
SECTION A-A
SCALE 1/4" = 1'-0"

NOTE
Anchors shall be embedded 6'-0" minimum in sound rock and 8'-0" minimum in weathered rock or as directed by the contracting officer. The spacing shown is minimum spacing and anchors shall be located in the field to avoid cracks, fractures, etc.
